# **HP 9133/9134 D/H/L Service Manual**

**Manual part number: 5957-6560**

**Printed: APRIL 1983  
Printed in U.S.A.**

**Edition 2  
E0488**

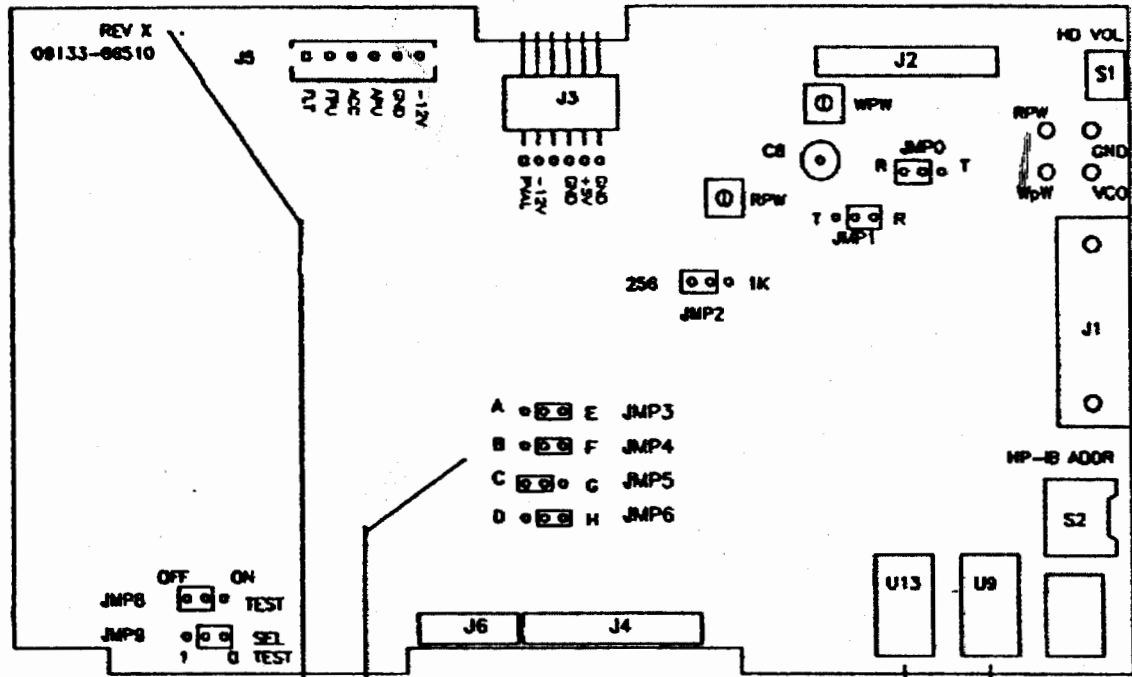
Product	S/N Prefix	Rev	JMP3-JMP6	Required Firmware
9133D	2419A/2511A	B	EFCH	Any 09133-8910X/-8920X
9133D	2419A/2511A	C	EFCD	09133-89105/-89205 and above
9133D	2513A and above	B	ABCH	09133-89105/-89205 and above
9133D	2513A and above	C	ABCD	09133-89105/-89205 and above
9134D	2425A	B	EFGH	Any 09133-8910X/-8920X
9134D	2425A	C	EFGD	09133-89105/-89205 and above
9134D	2514A and above	B	ABGH	09133-89105/-89205 and above
9134D	2514A and above	C	ABGD	09133-89105/-89205 and above
9133H	ALL	B	AFCH	09133-89105/-89205 and above
9133H	ALL	C	AFCD	09133-89105/-89205 and above
9134H	ALL	B	AFGH	09133-89105/-89205 and above
9134H	ALL	C	AFGD	09133-89105/-89205 and above

NOTE: JMP2 is shown in the position for standard product.  
Option001 will have JMP2 in 1K position.
