# **CE SERVICE HANDBOOK FOR 79XX SERIES DISC DRIVES**

## **7908 DISC/TAPE DRIVE**

Part no. 07908-90905

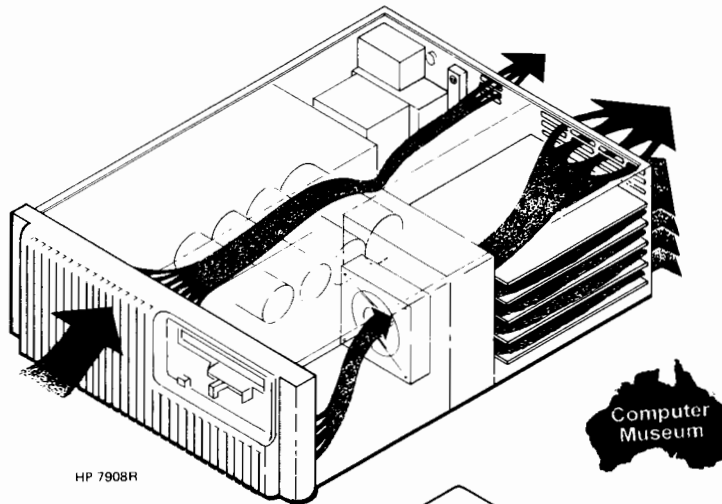
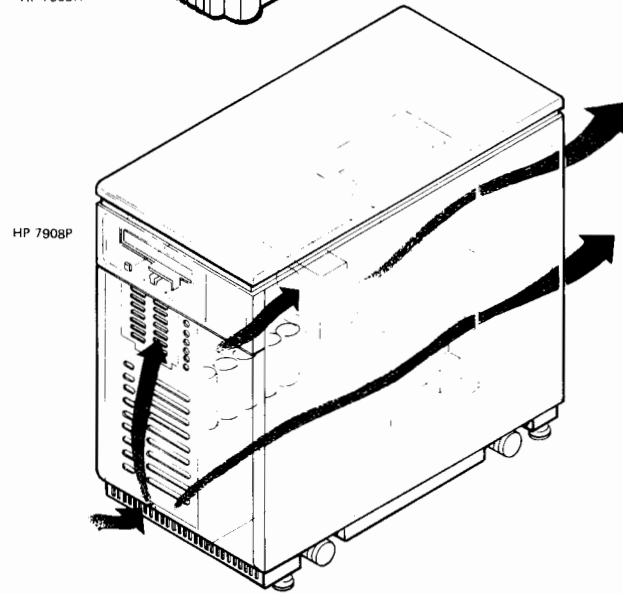
Figure 2-1. Cooling Requirements

MAINTAIN AT LEAST 75 MM (3 IN.) CLEARANCE FRONT AND REAR.

SEALED DISC MECHANISM - NO AIR FILTERS REQUIRED

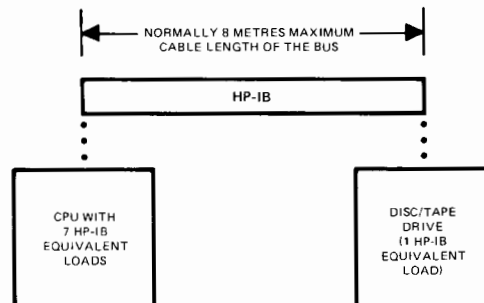
Cabling is limited to one metre per HP-IB load. Typically, the host system is seven equivalent loads and the disc/tape drive is one equivalent load.

In multi-drive systems, the HP standard allows seven metres of cable between the host and the nearest device, and one metre between each additional device. The maximum configuration is eight devices (not including the CPU) per HP-IB channel or a maximum of 15 metres or 15 equivalent loads.

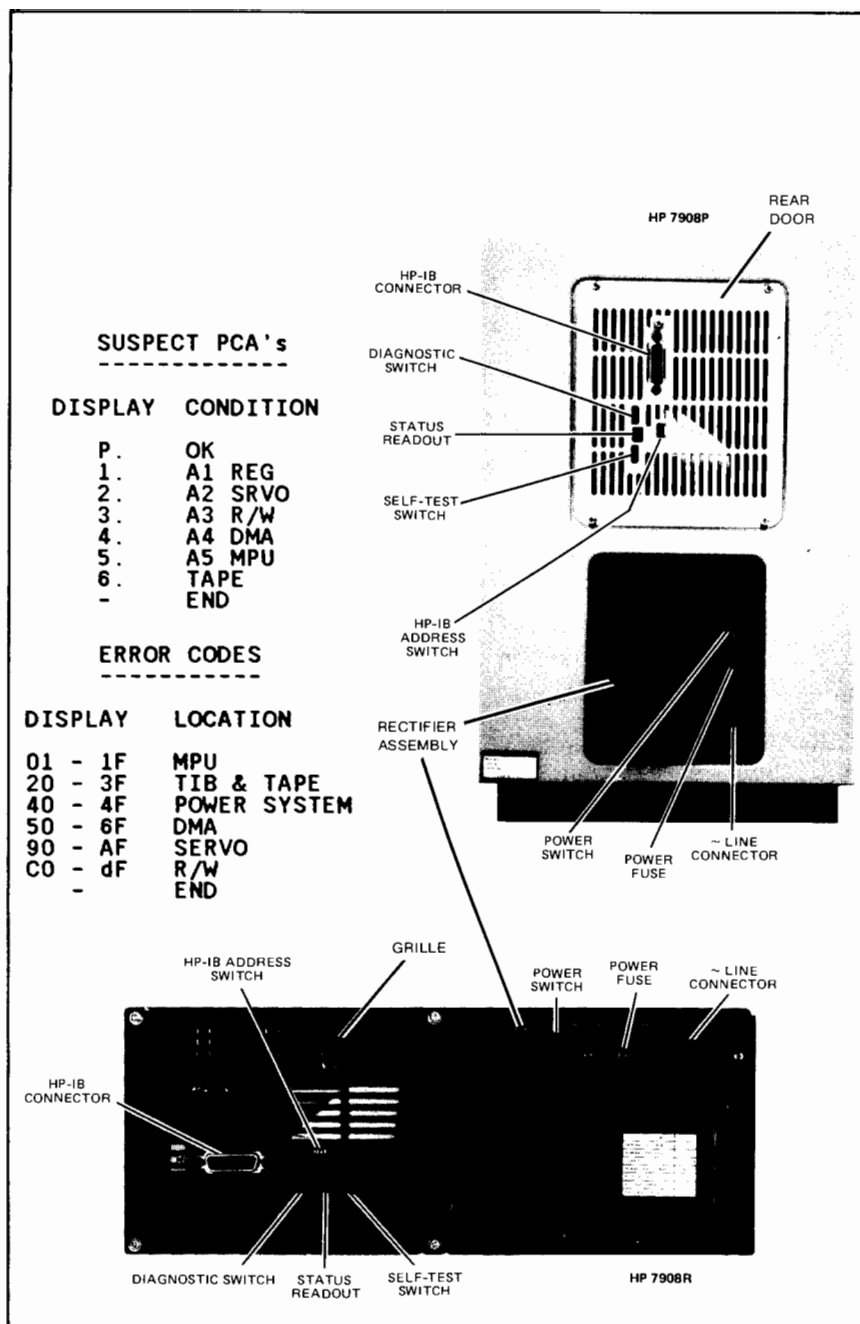
Figure 2-2. Rear Panel Switches and Indicators

Self test is invoked with each power-up, taking 1 to 3 minutes depending on tape installed. "P." indicates pass, a number indicates suspect PCA. (See figure 2-2 for switch locations.)

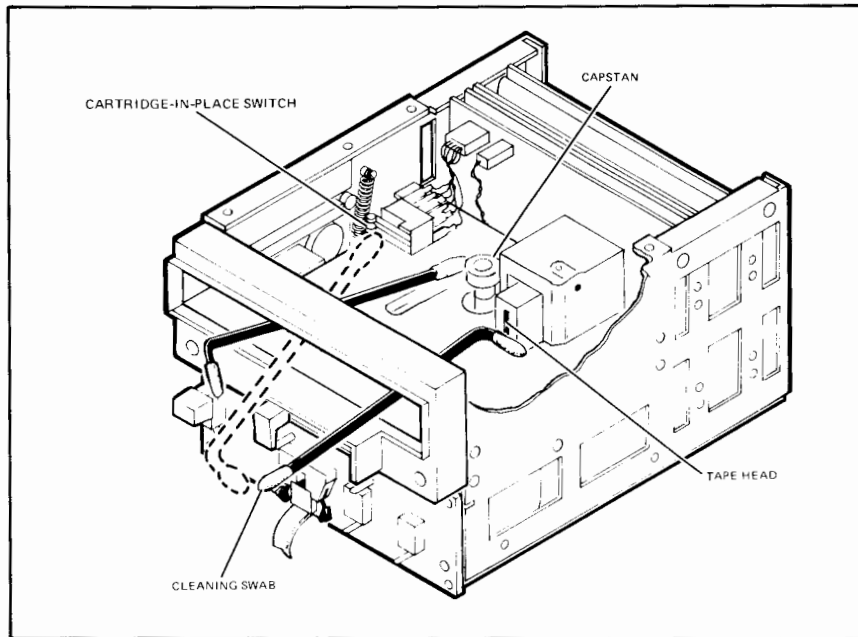
Figure 2-4. Tape Head Cleaning

1. With power ON and cartridge removed, momentarily press lower part of cartridge-in-place switch. Wait for head to raise. (See CAUTIONS.)
2. Dampen swab straight end and clean rotating capstan.
3. Dampen swab bent end and clean head with up and down motion. Press cartridge-in-place switch again to release head and stop capstan. (Ignore buzzing sound.)
